Situation Photo Log

Thursday, September 13, 2012

Kalamazoo River / Enbridge Spill

Prepared by:
Matthew Haak
START-USEPA
Situation Unit Leader

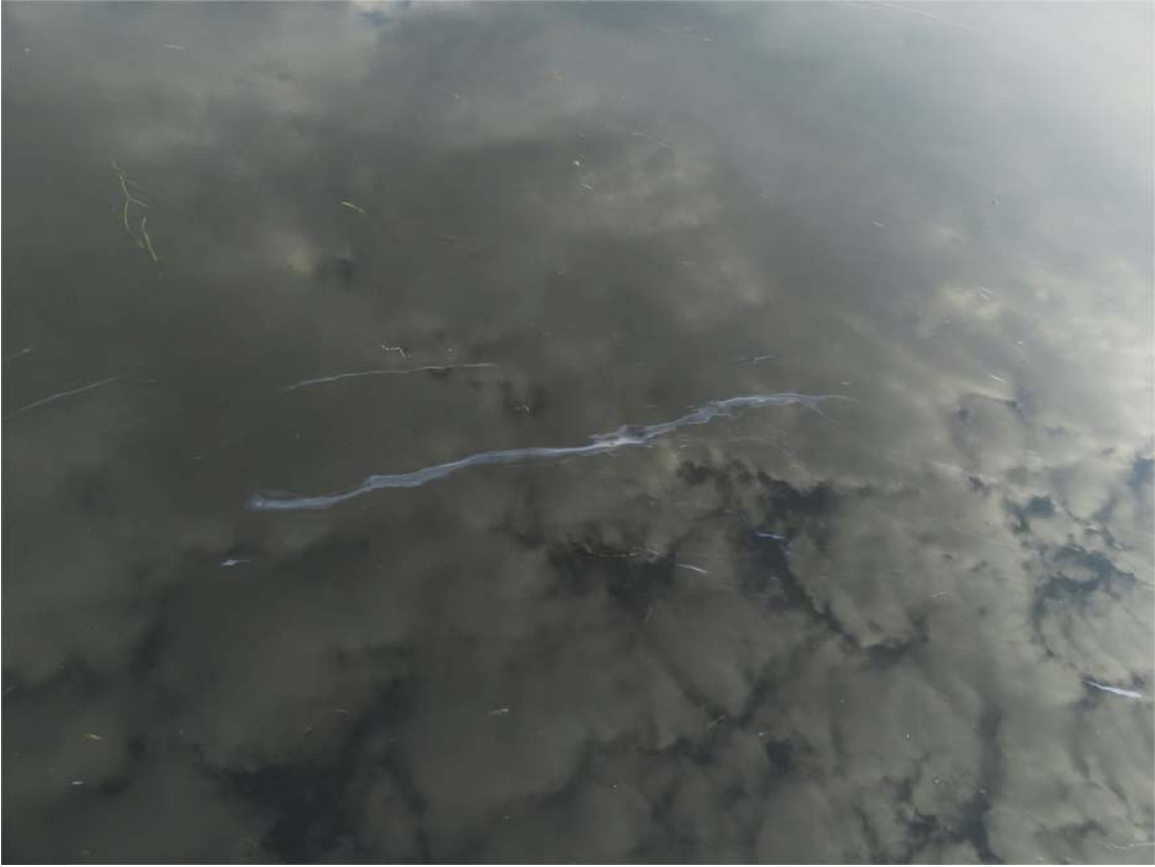
1. Sheen and tar globules observed at MP5.0 LDB.

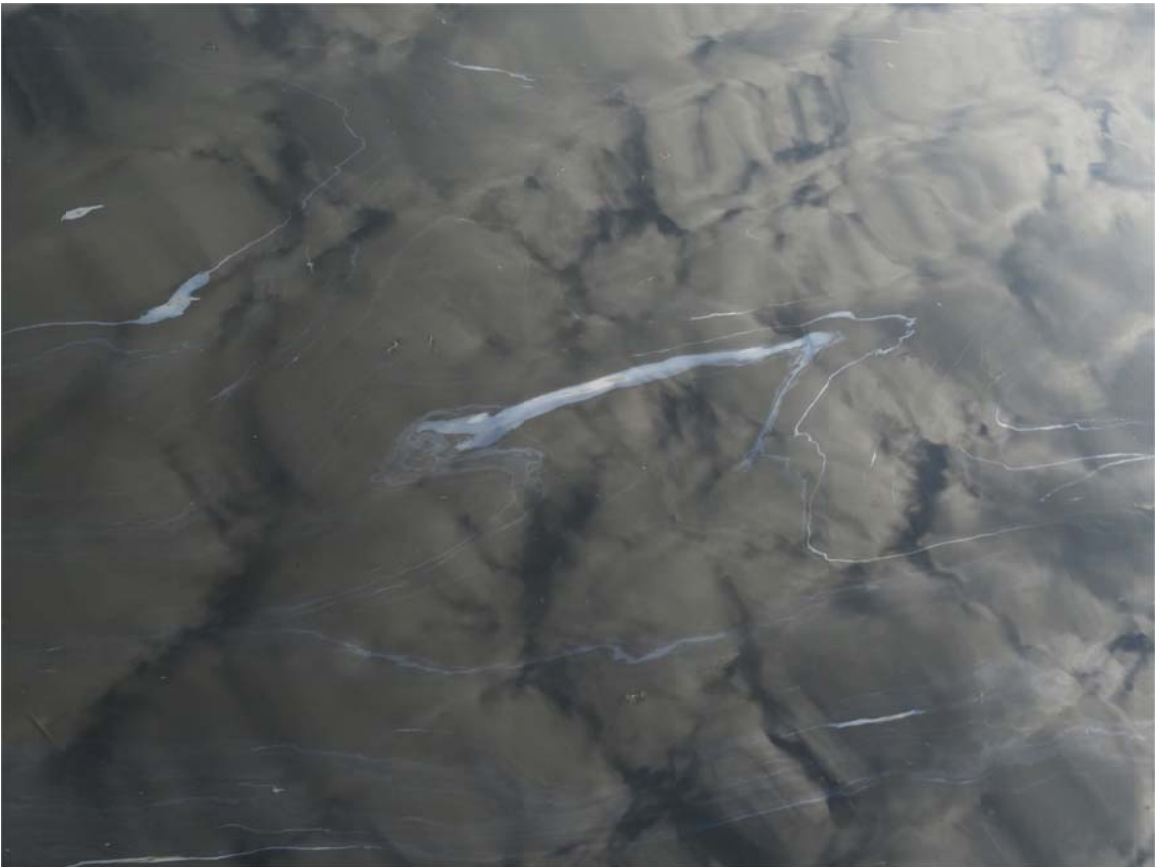
2. Sheen and tar globules observed at MP5.45 LDB.

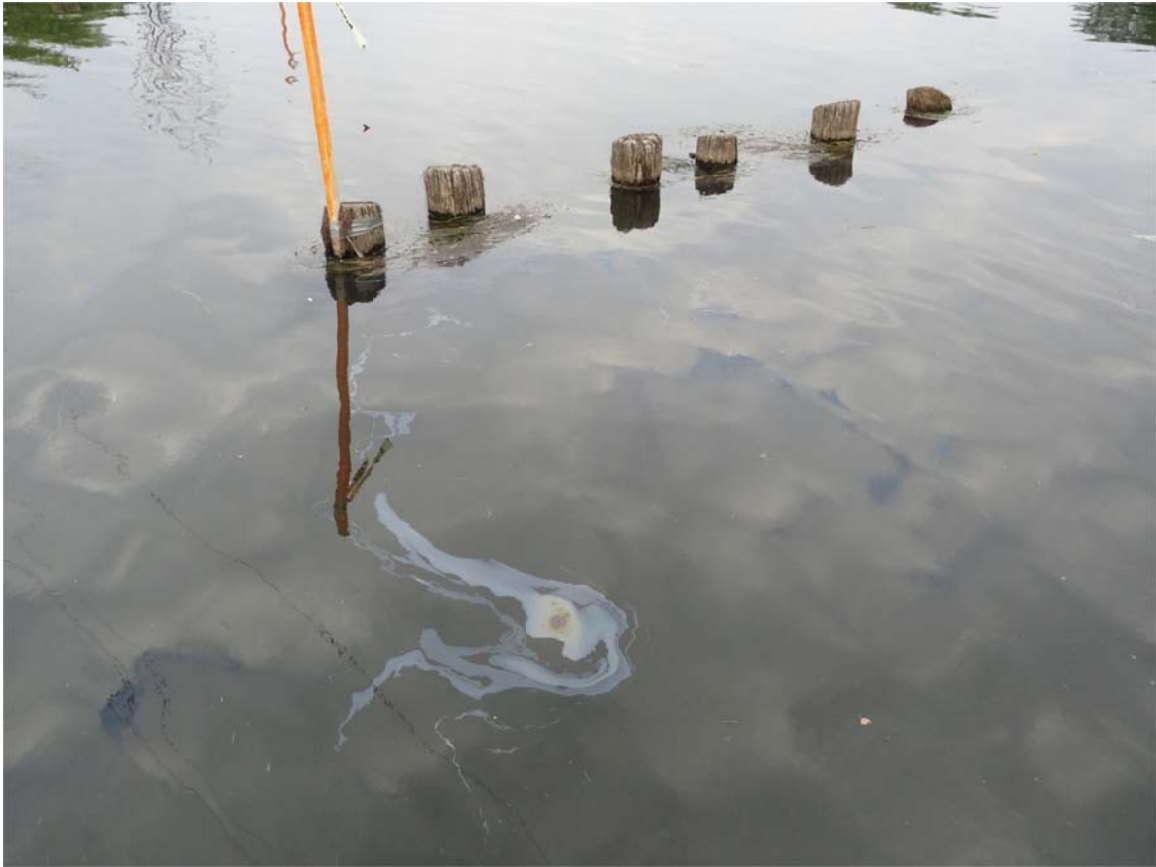
3. MP5.63 LDB at the railroad trestles sheen and tar globs observed.

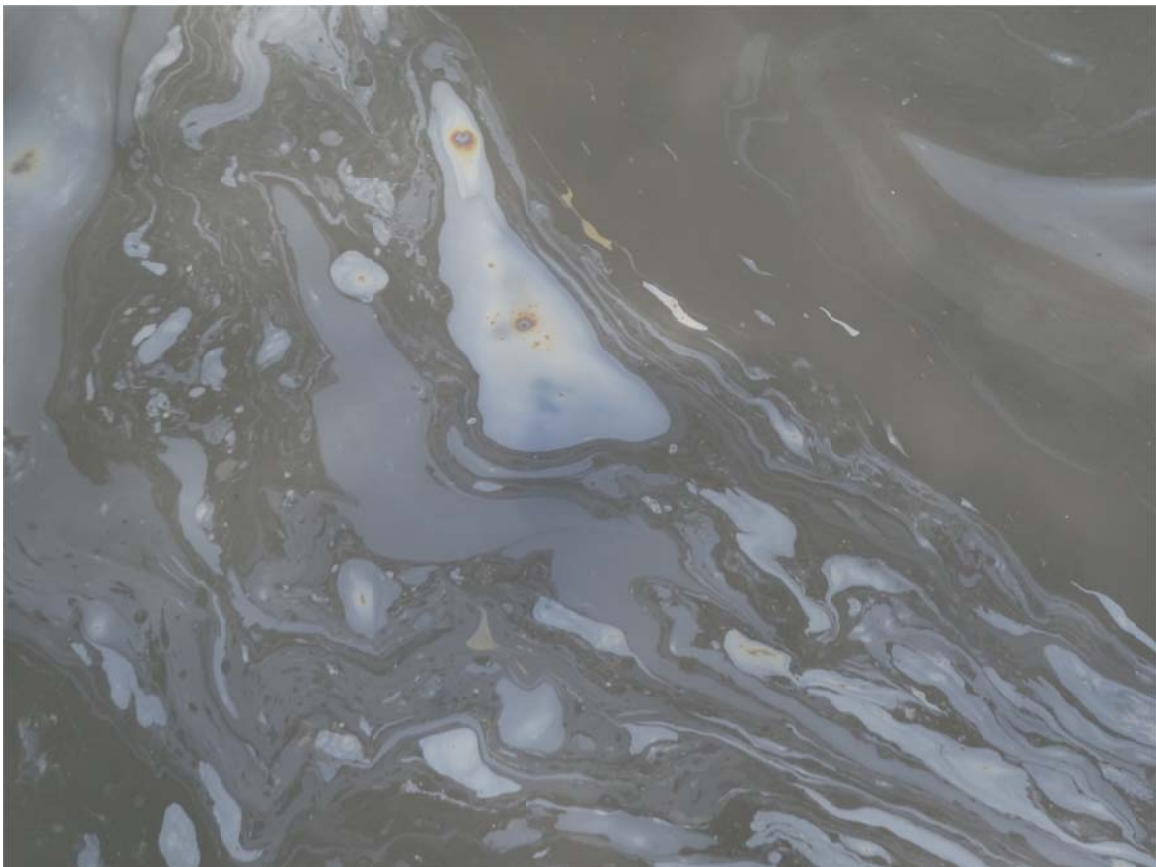
4. MP5.63 LDB below the railroad trestles sheen and tar globs observed.

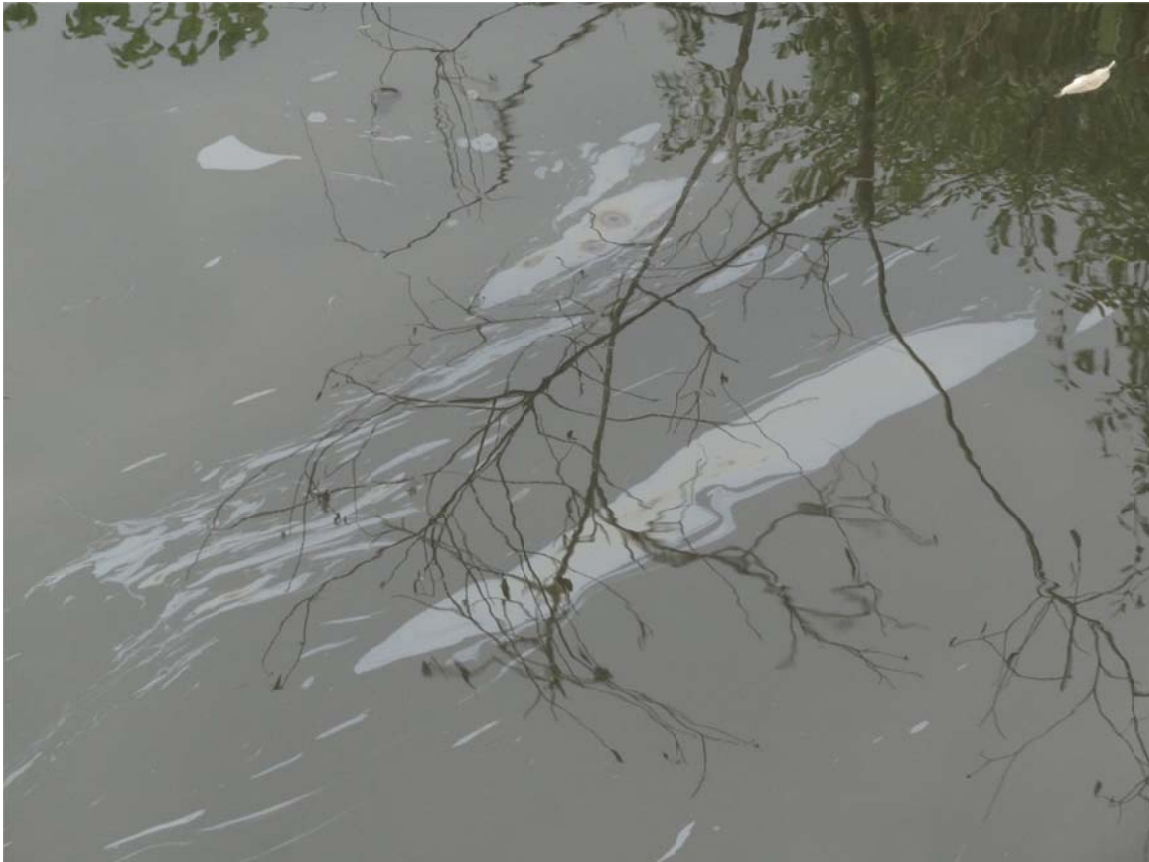
5. MP5.63 LDB below the railroad trestles sheen and tar globs observed.

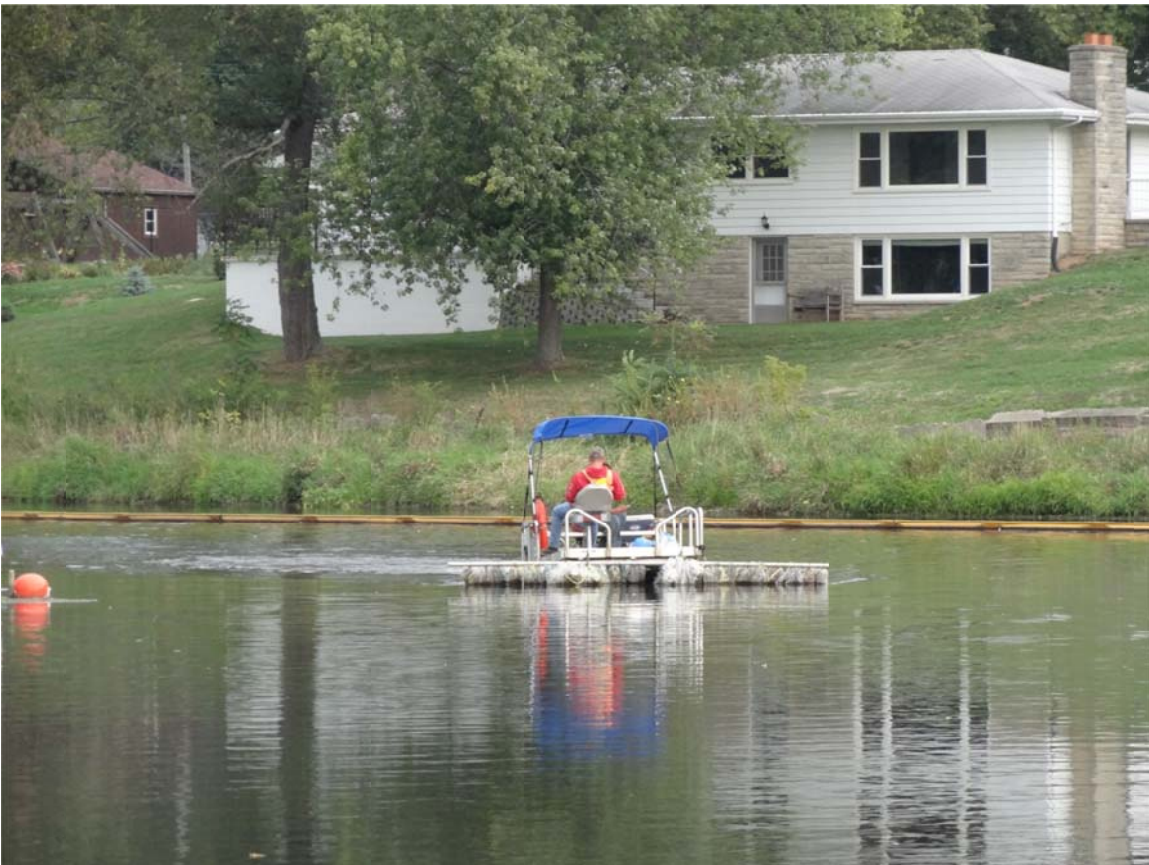
6. Ceresco Dam sheen sweep boat operating.

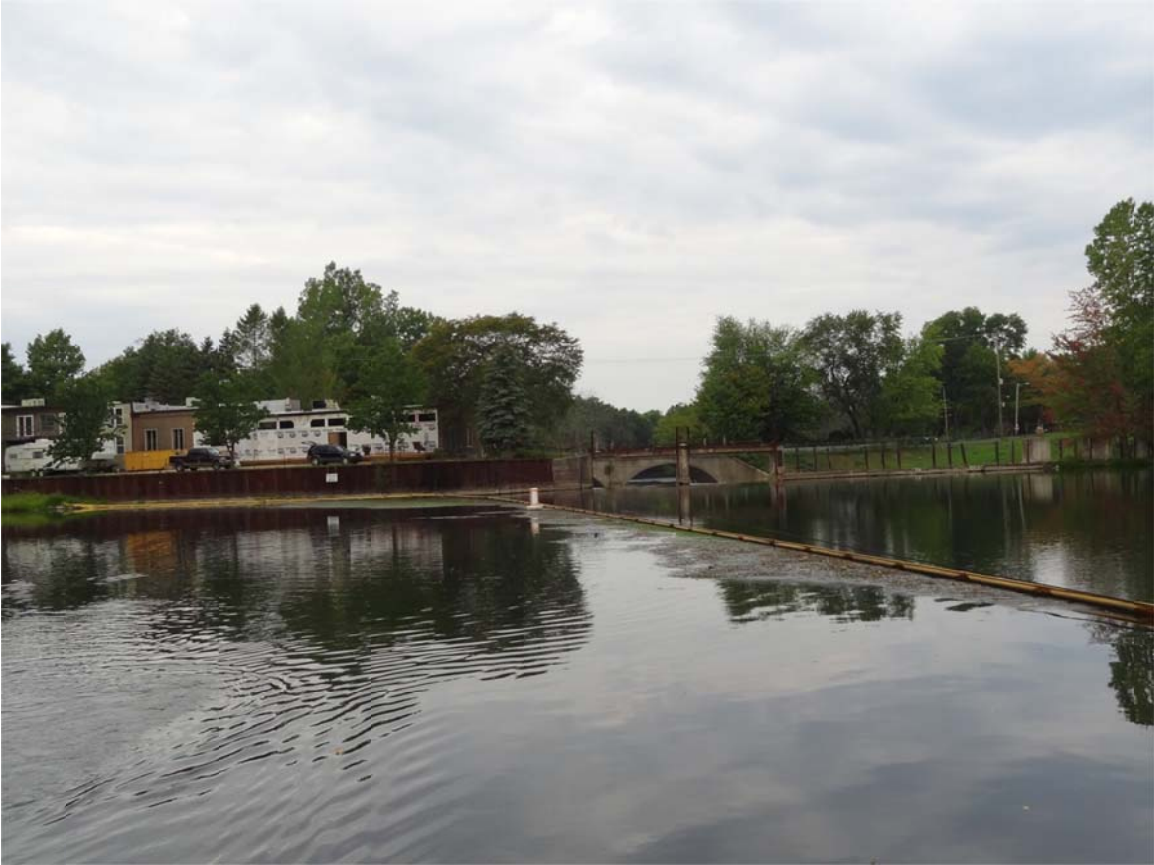
7. Ceresco Dam observed debris collecting along the boom.

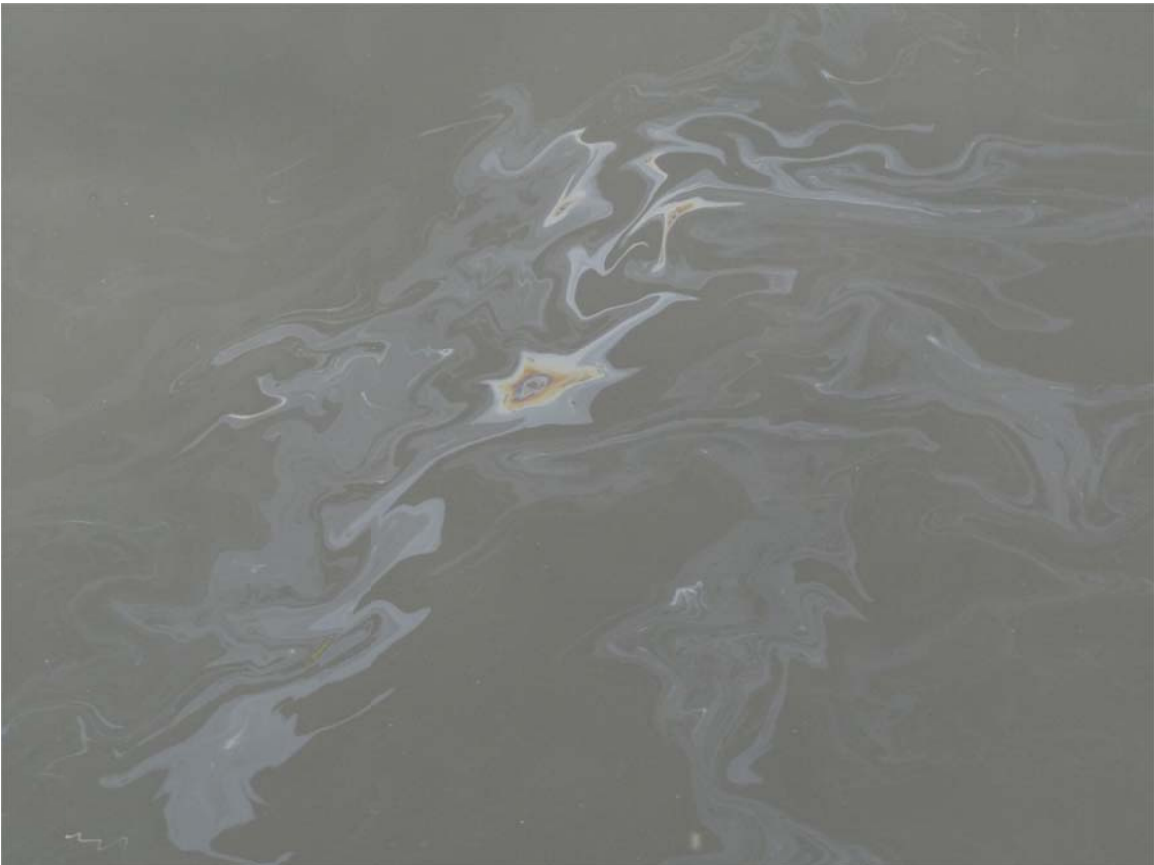
8. Ceresco Dam sheen observed collecting along the boom.

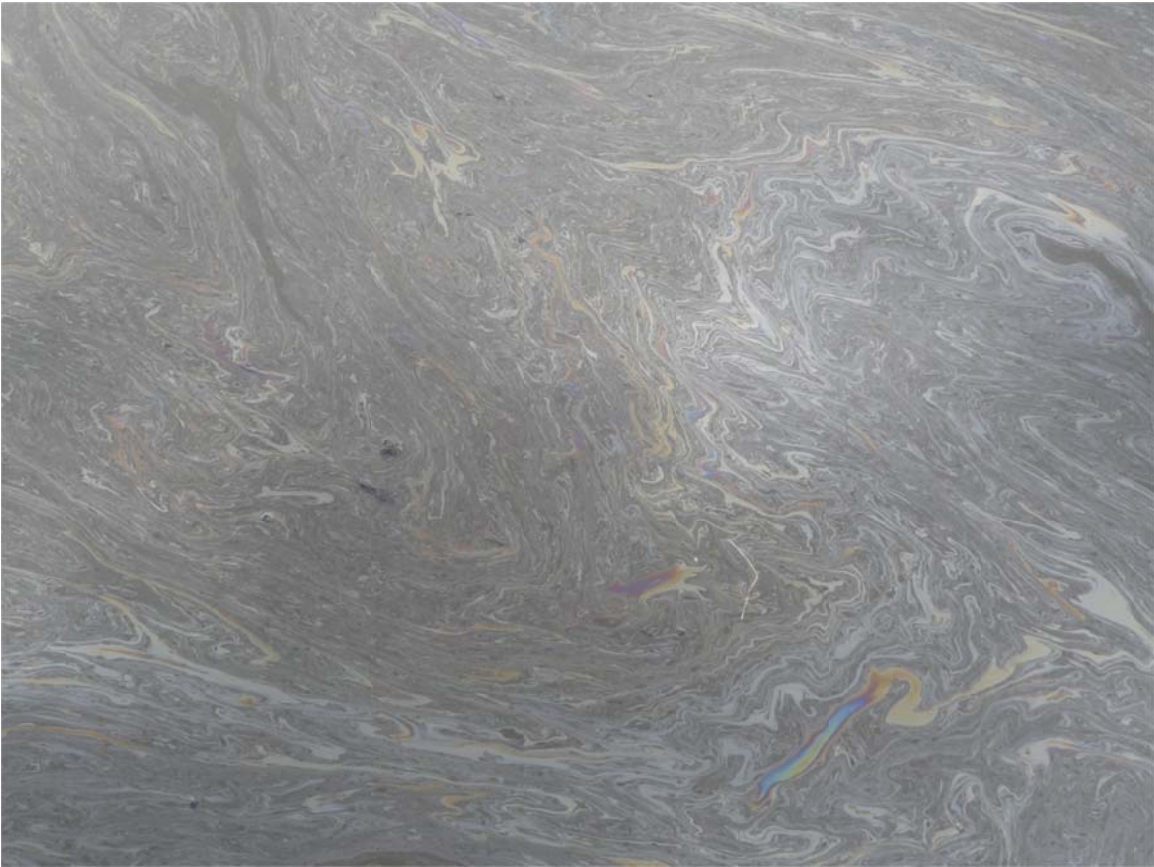
9. Ceresco Dam sheen and tar globs observed after a boat agitated the sediment.

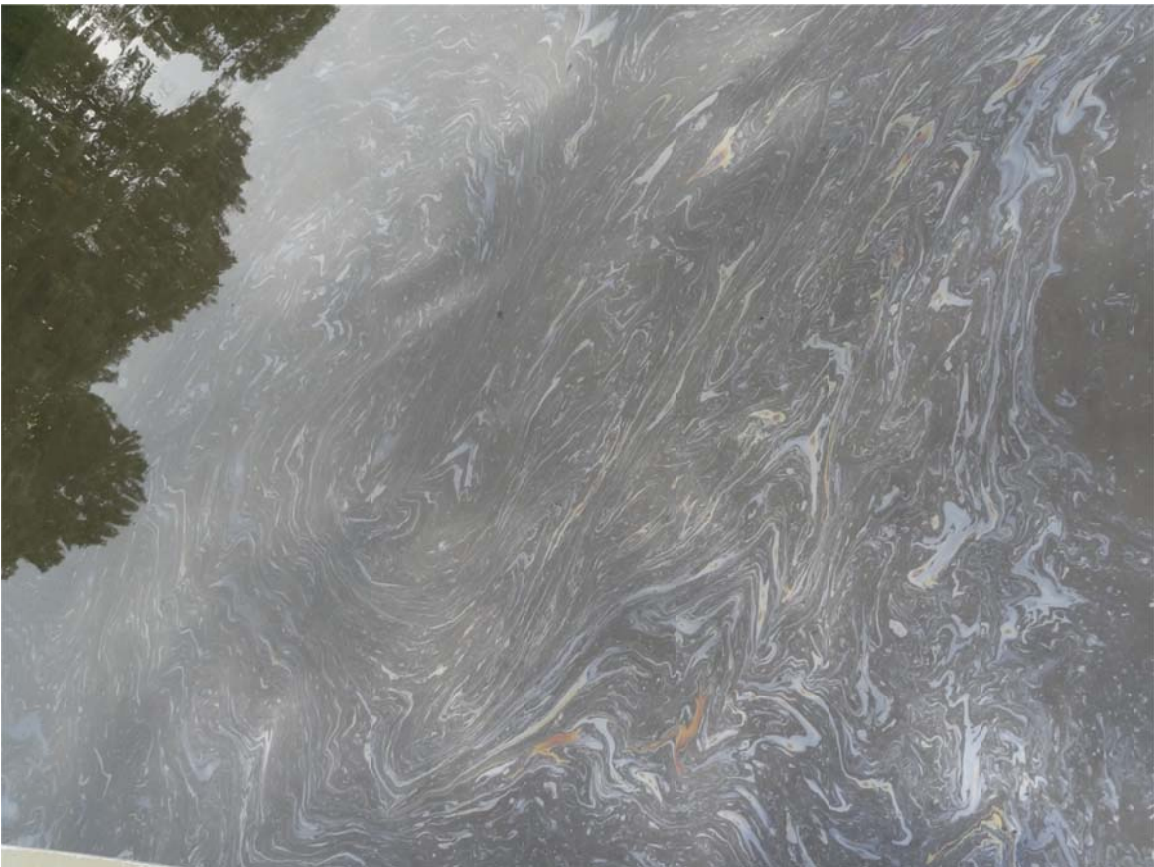
10. Ceresco Dam sheen and tar globs observed after a boat agitated the sediment.

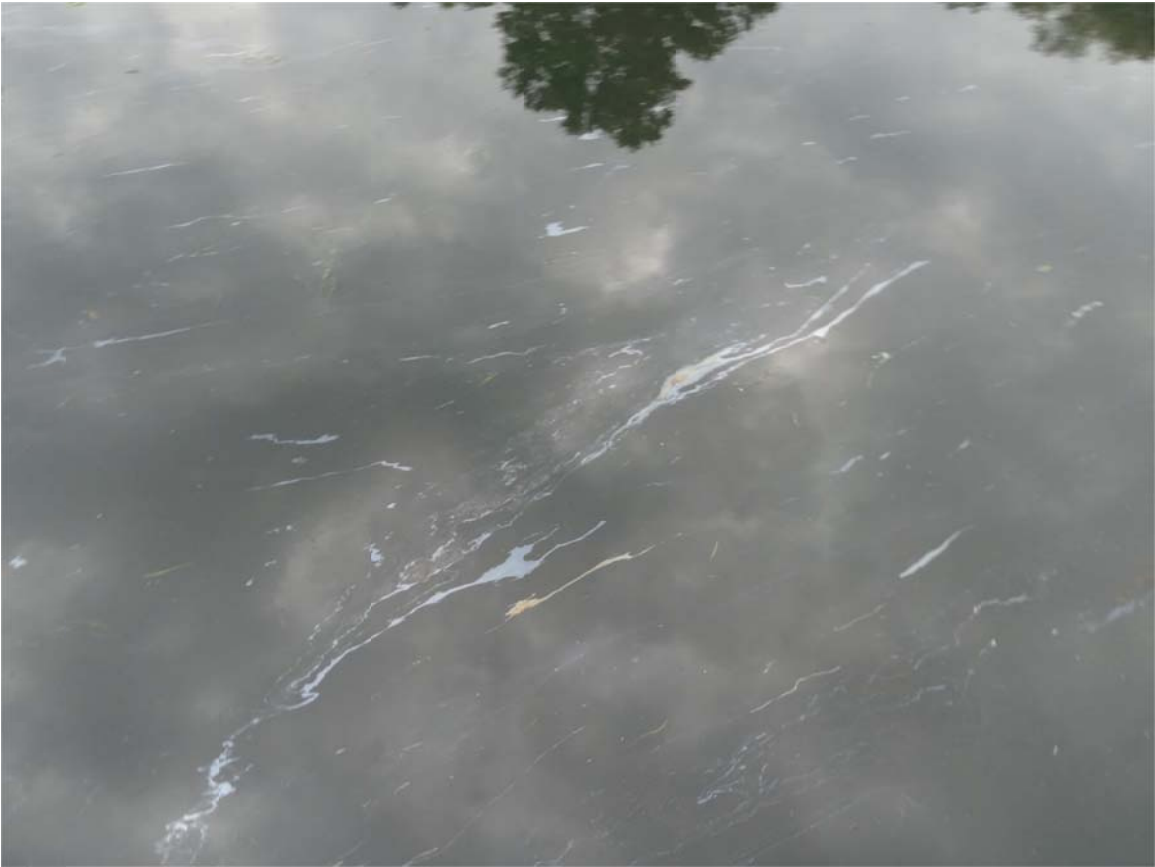
11. MP5.63 RDB sheen and tar globs observed.

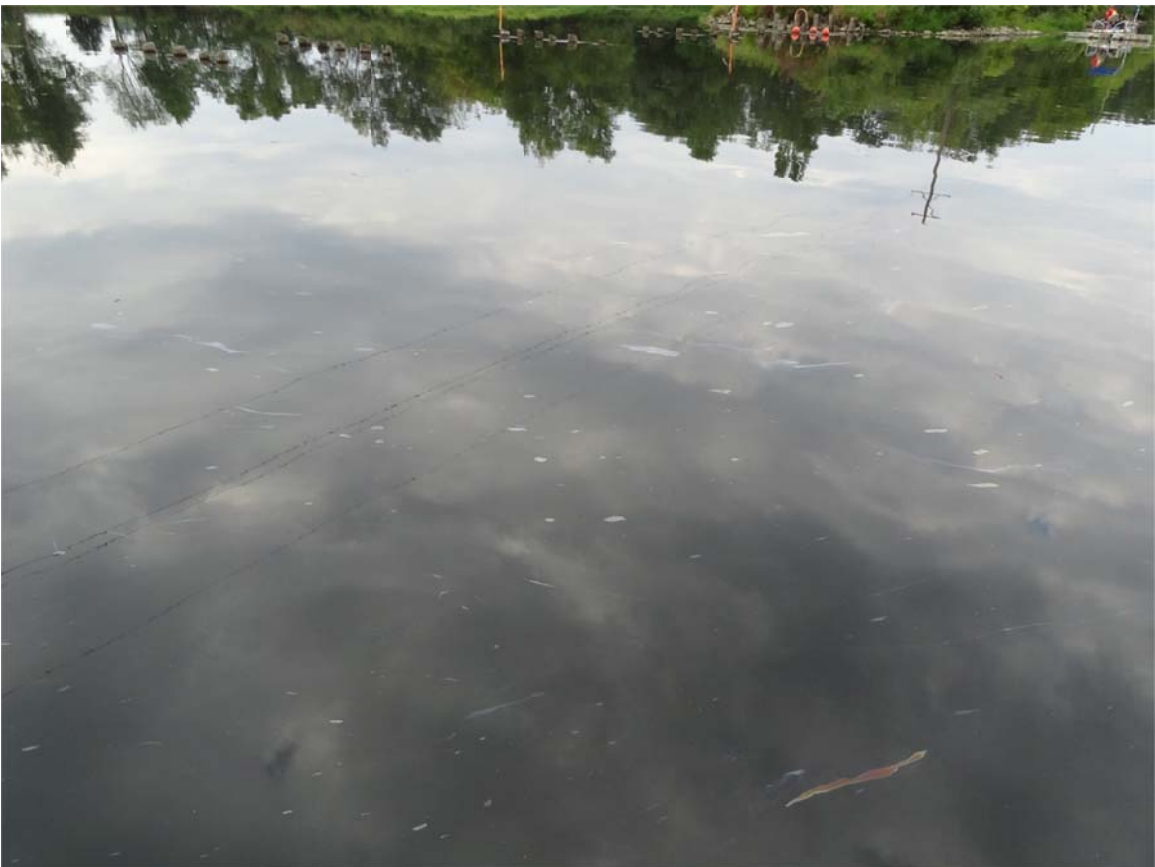
12. MP5.63 RDB sheen and tar globs observed.

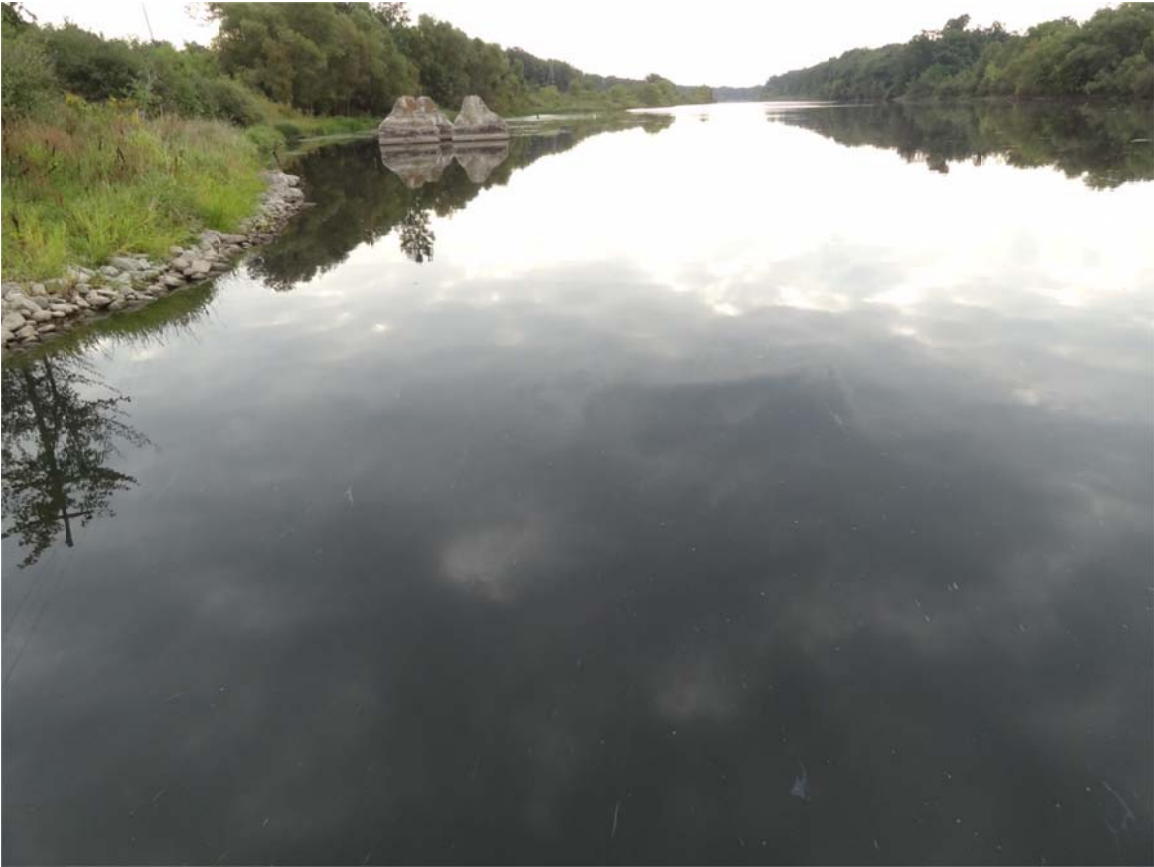
13. MP5.55 RDB sheen and tar globs observed.

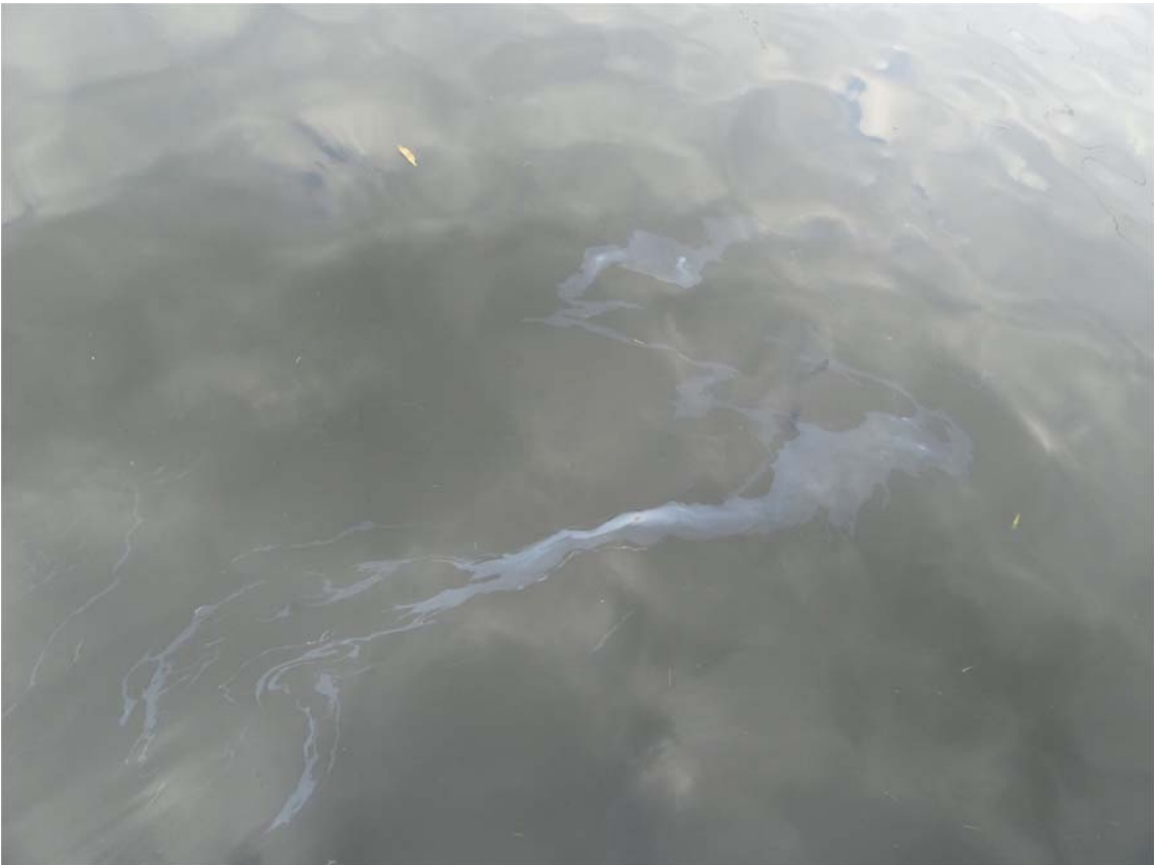
14. MP5.55 RDB sheen and tar globs observed.

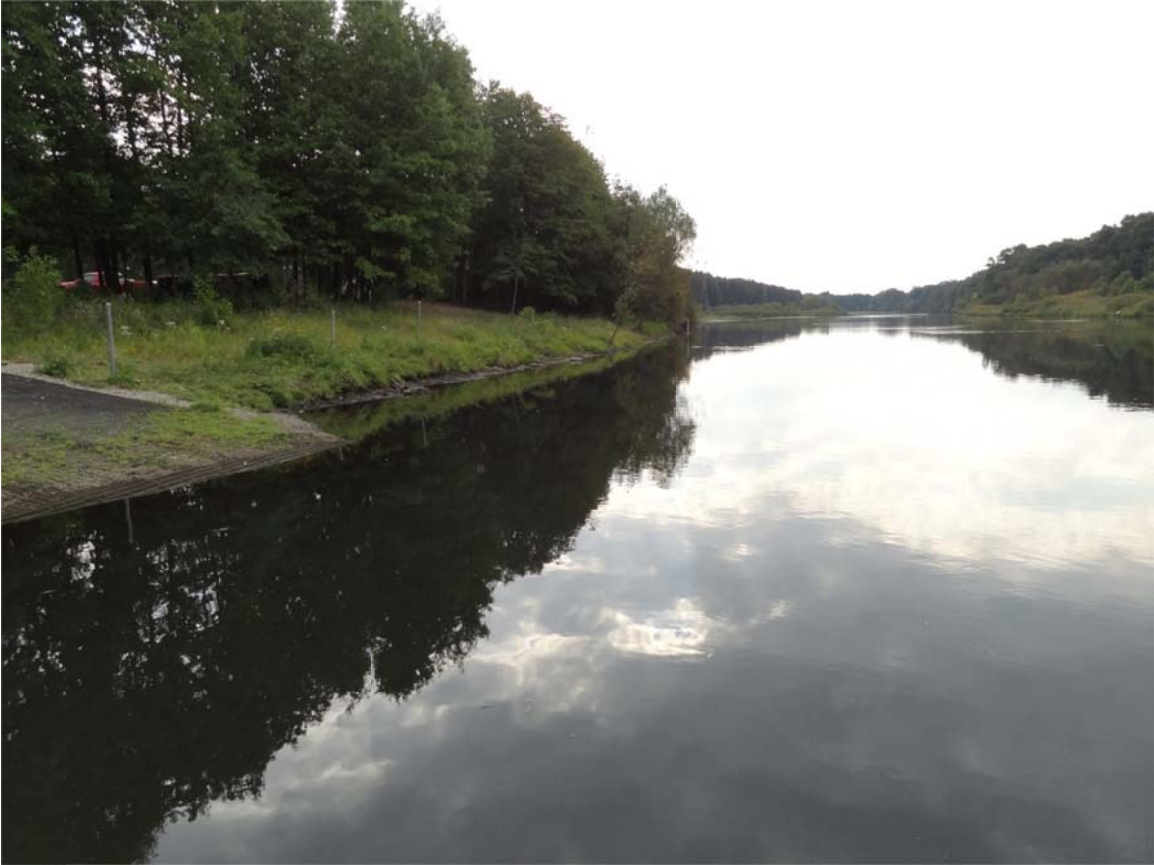
15. MP5.0 – MP5.15 RDB area where sheen was observed.

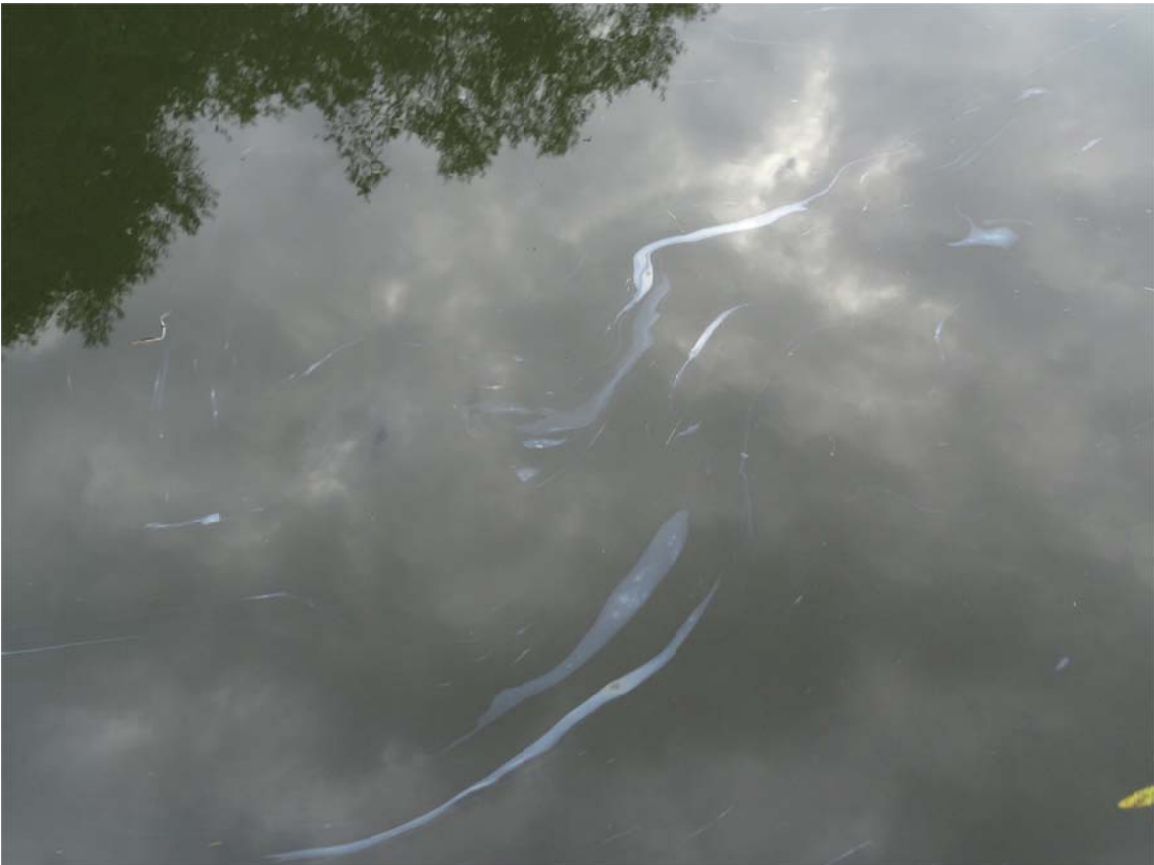
16. MP5.0 – MP5.15 RDB sheen and tar globs observed.

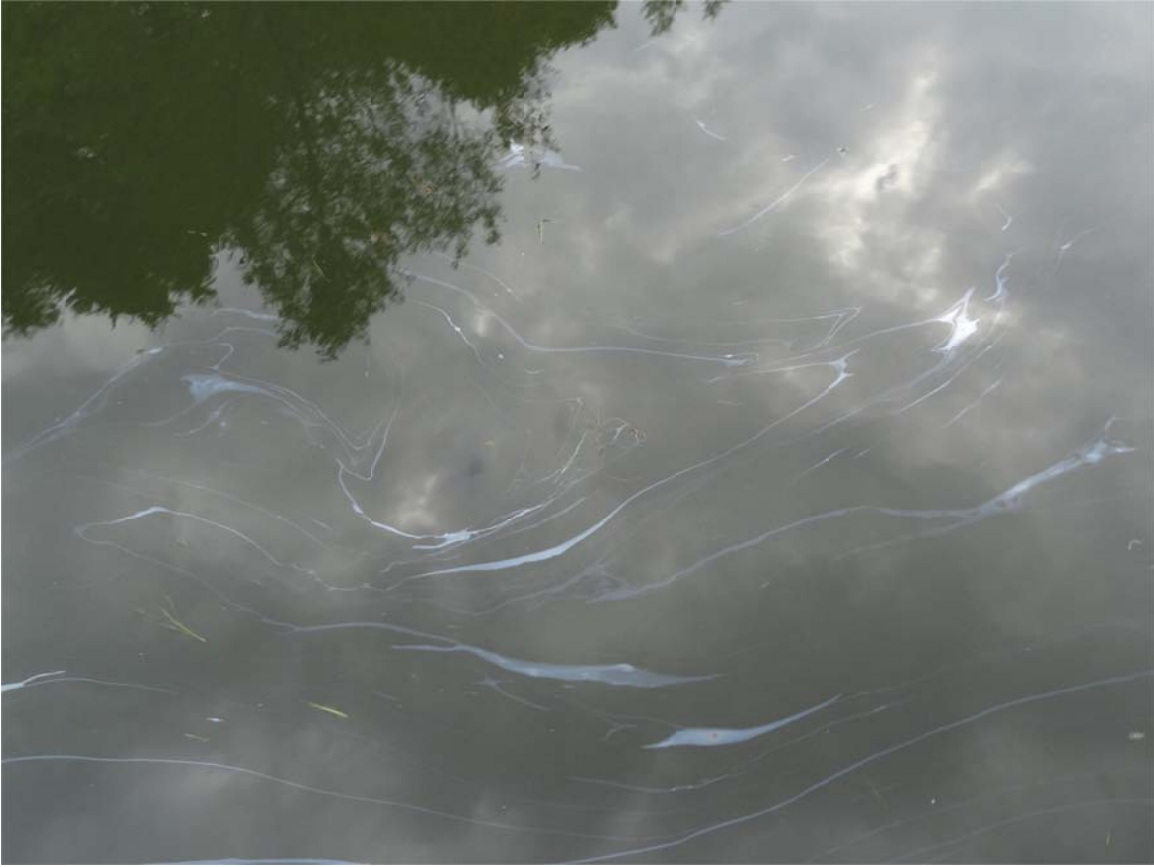
17. MP5.0 – MP5.15 RDB sheen and tar globs observed.

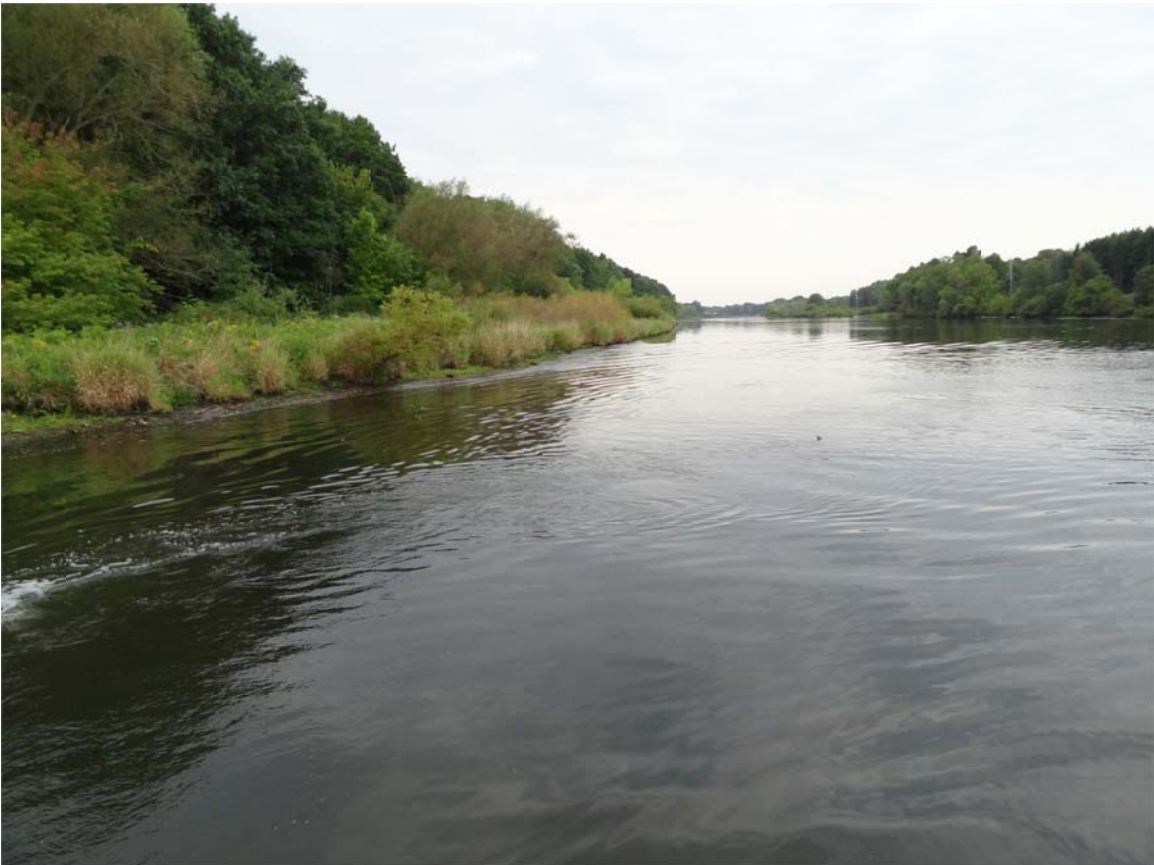
18. MP5.0 LDB area where sheen was observed.

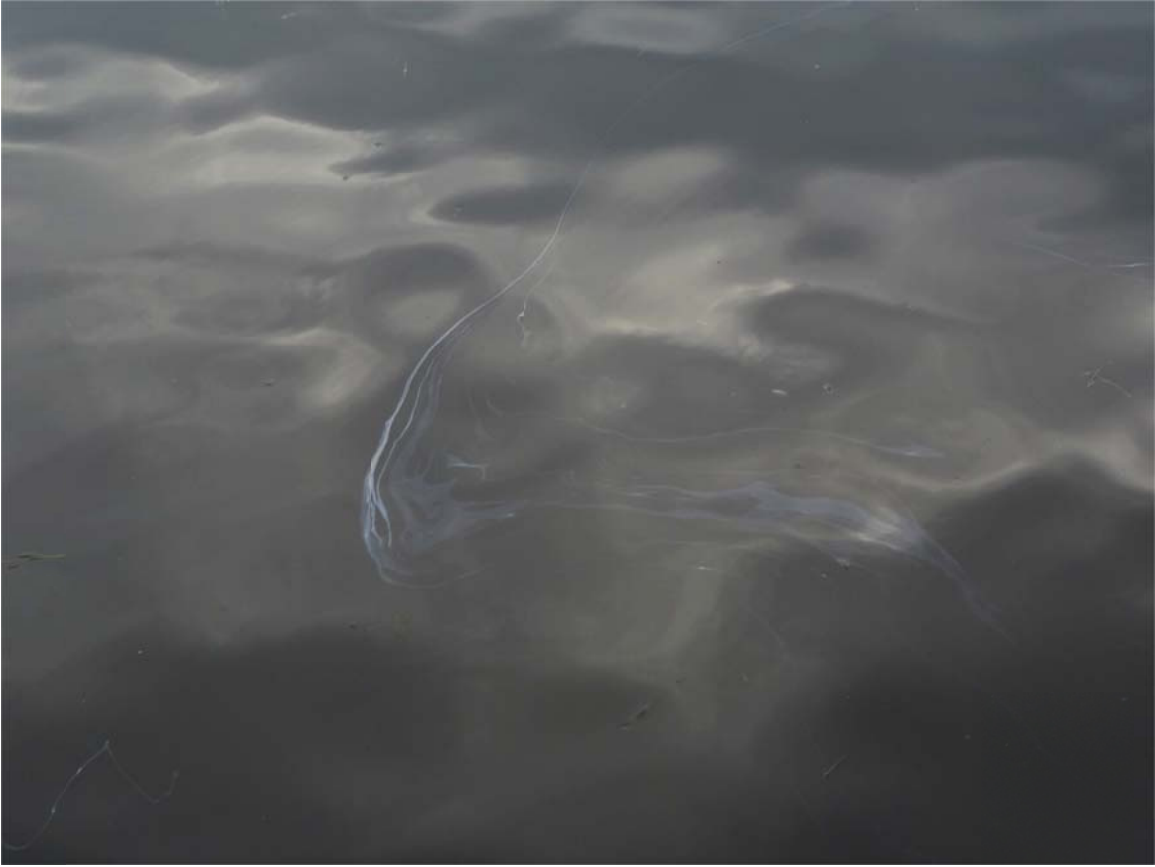
19. MP5.0 LDB sheen observed.

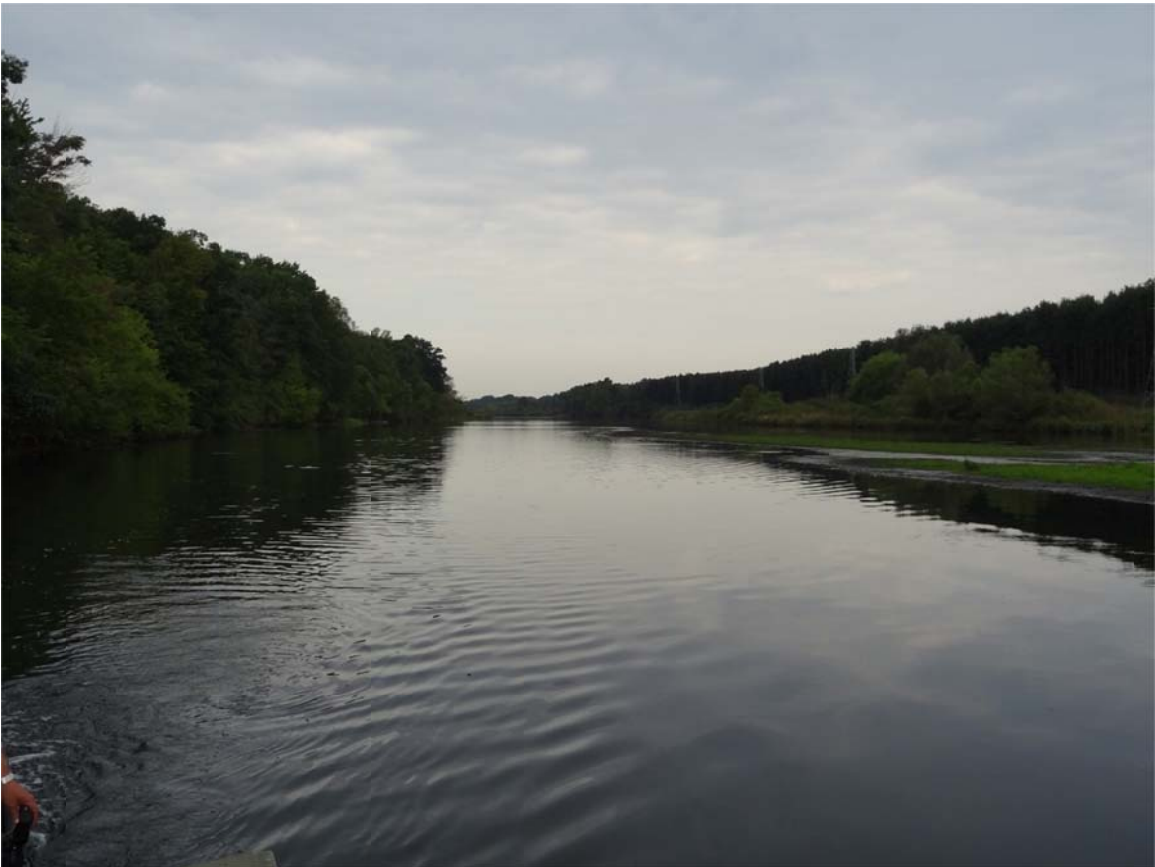
20. MP4.75 LDB area where sheen was observed.

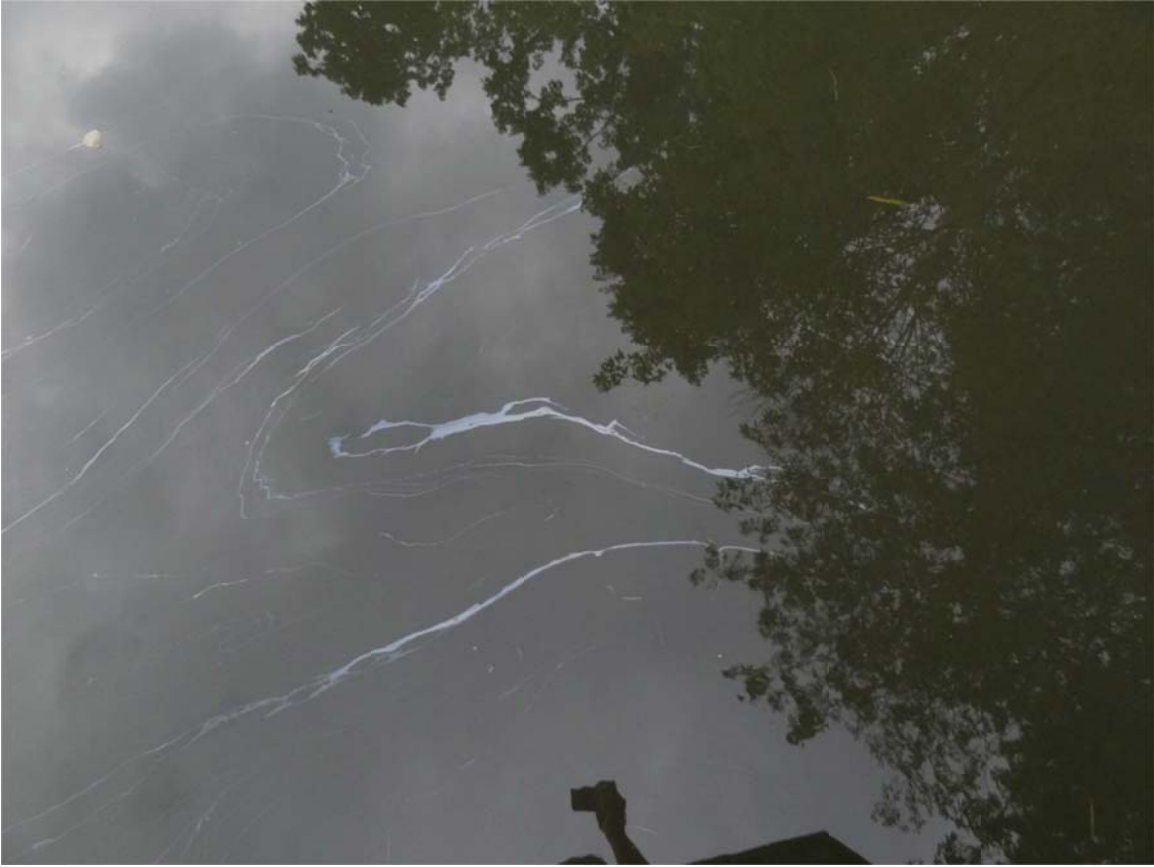
21. MP4.75 LDB sheen observed.

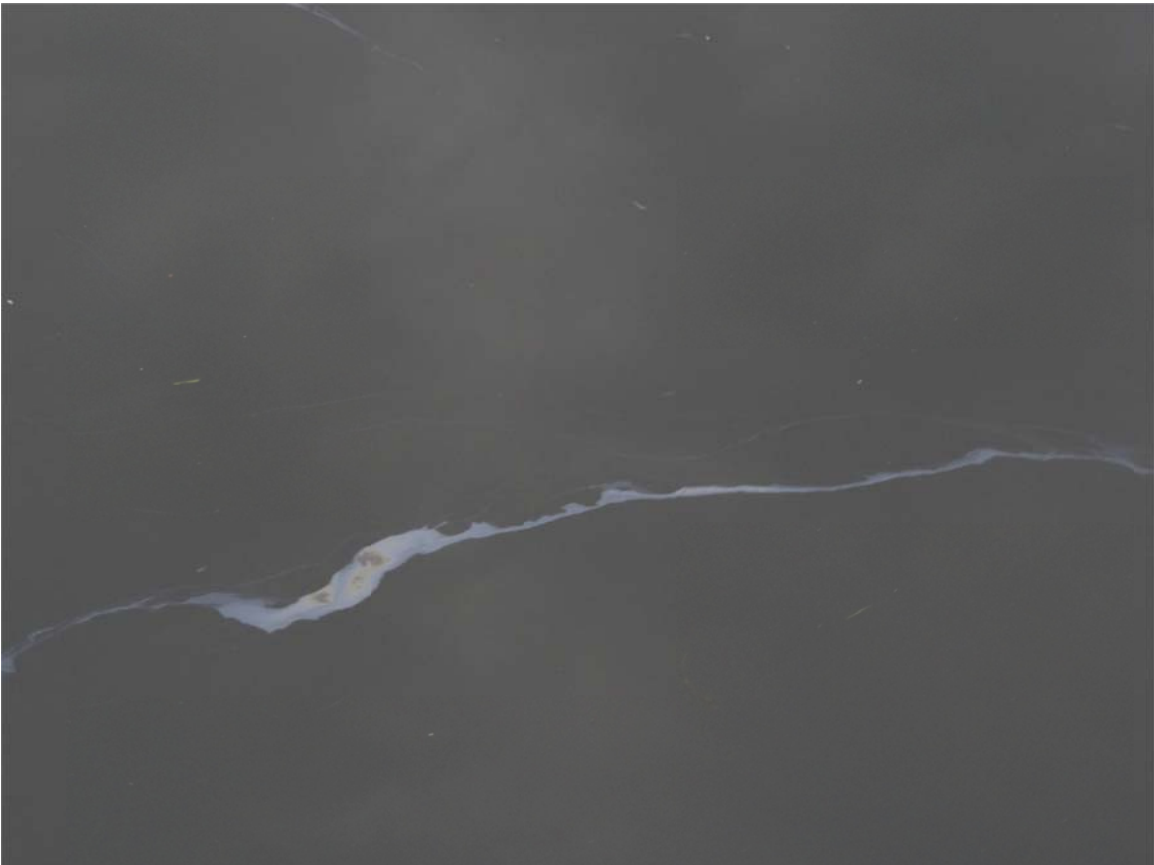
22. MP4.75 LDB sheen and tar globs observed.

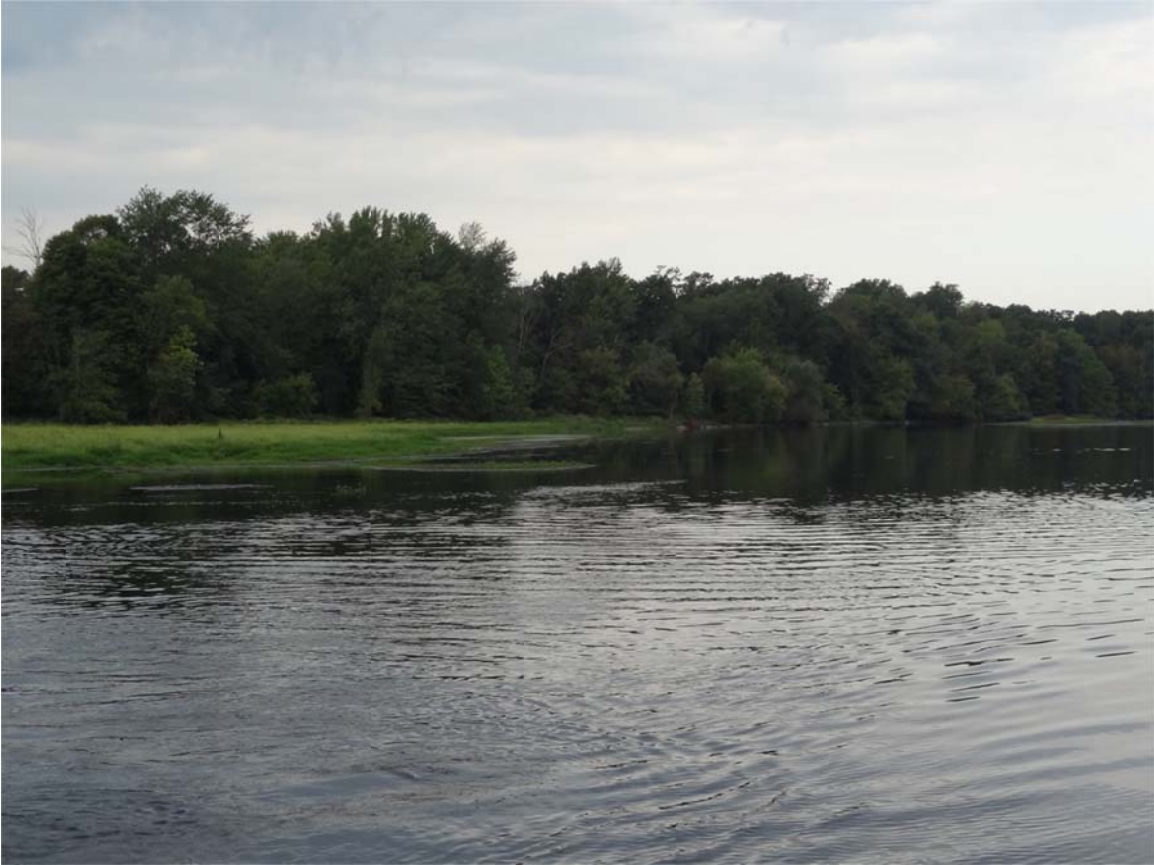
23. MP4.5 LDB area where sheen was observed.
